FACTUAL NOTES, ENGINE TEARDOWN INVESTIGATION IN SUPPORT OF ACCIDENT INVESTIGATION OF BEECHCRAFT B-90 REG. N338AS PERFORMED FOR THE NATIONAL TRANSPORTATION SAFETY BOARD.

PT6A-20 S/N 20801

PT6A-20 S/N 22008

Report No.: TL-1503

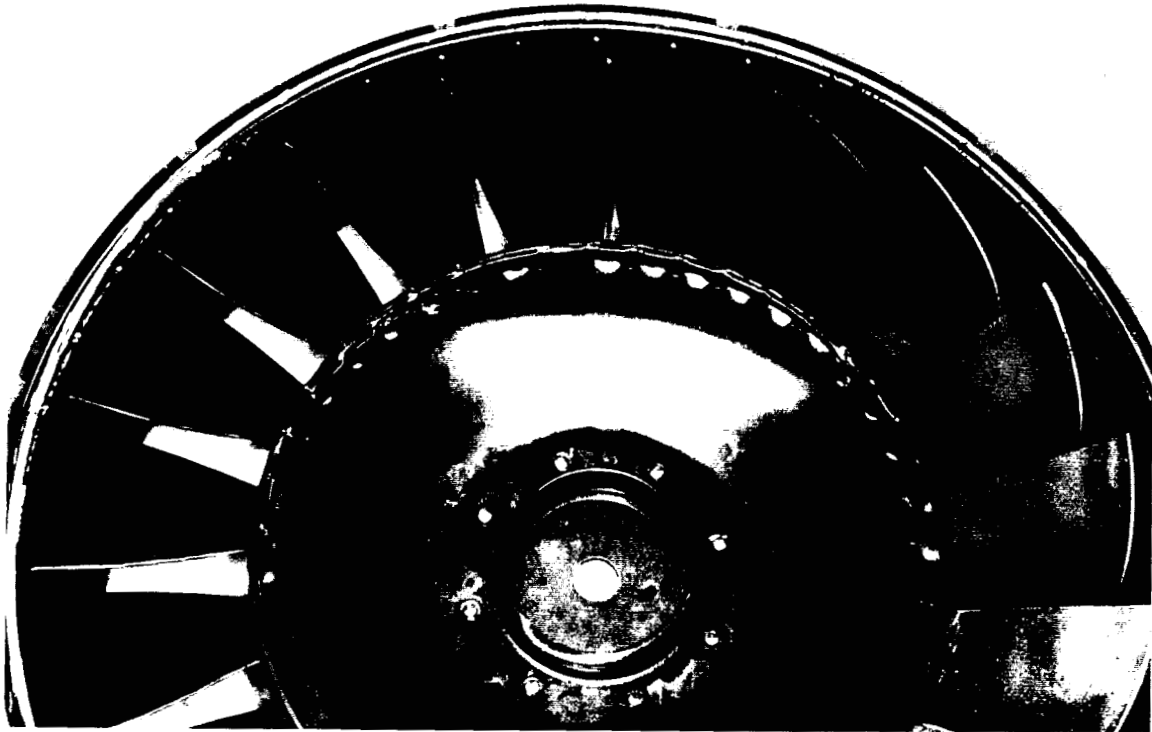
Photo No. 51

Power Turbine Guide Vane Ring and Interstage Baffle: The vane airfoils displayed no indications of operational distress. The inner drum downstream side and interstage baffle outer rim were lightly circumferentially rubbed due to axial contact with the compressor turbine disc. The baffle inner cup was circumferentially scored and radially deformed due to contact with the disc hub spigot. The downstream side outer drum displayed light circumferential scoring, with concurrent static imprint marks, due to axial contact with the power turbine blade tip shrouds. The inner drum and baffle outer rim displayed light circumferential rubbing, with heavy static imprint marks and tearing of the baffle outer rim around the upper circumference, due to axial contact with the power turbine disc. The baffle inner cup was deformed due to contact with the power turbine hub spigot.

Power turbine guide vane ring and interstage baffle downstream side, detail.
